DOCUMENT NO. D290-75303-2 Vol. III

TITLE IUS Program: Shock Analyses and Shock Tests

This volume of D290-75303-2 contains shock analysis and shock test results performed in support of the Inertial Upper Stage (IUS) program.

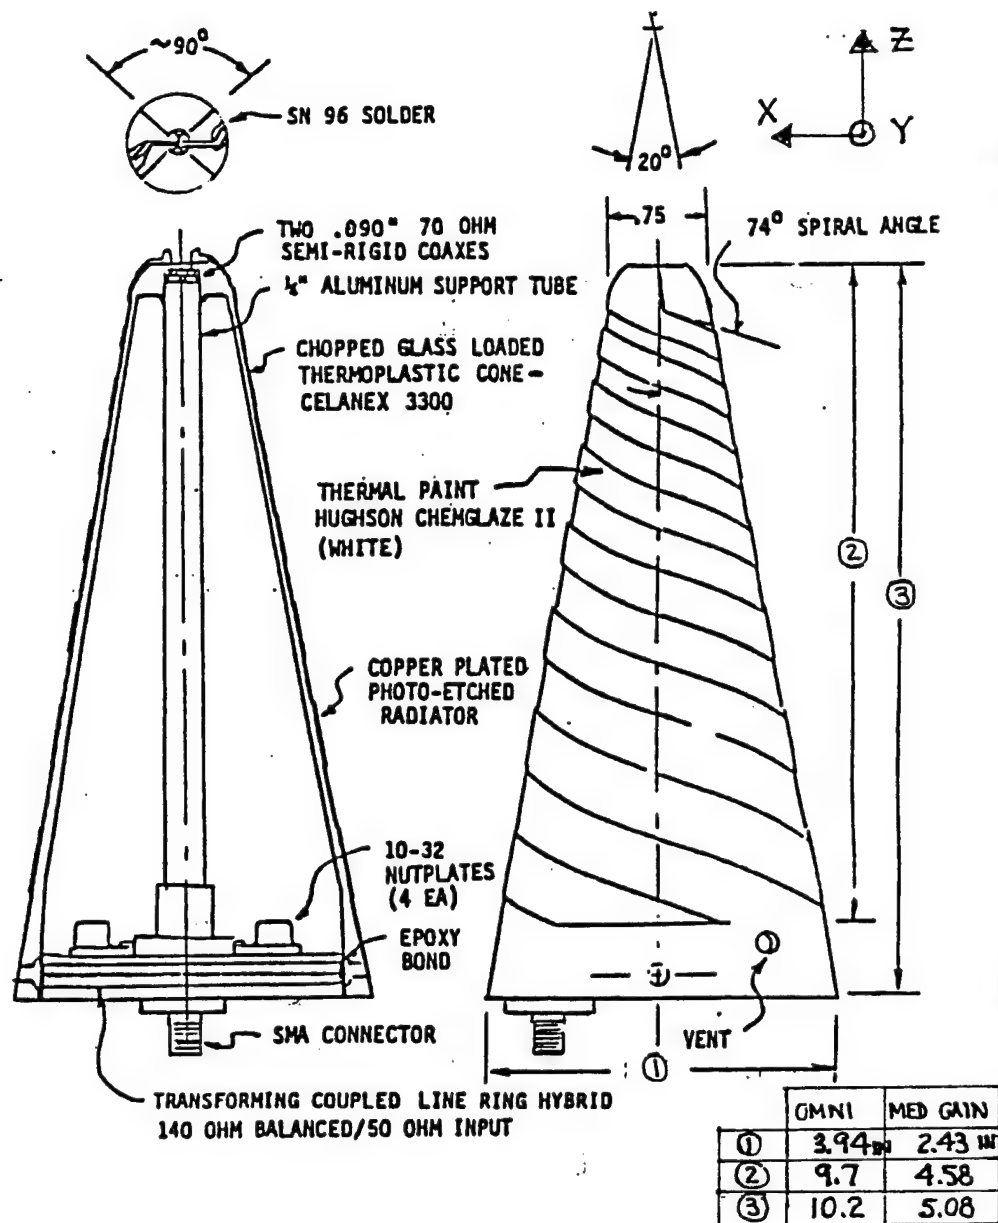
Medium Gain Antenna shown, Omni Antenna construction similar

FIGURE 5-19 ANTENNA CONSTRUCTION

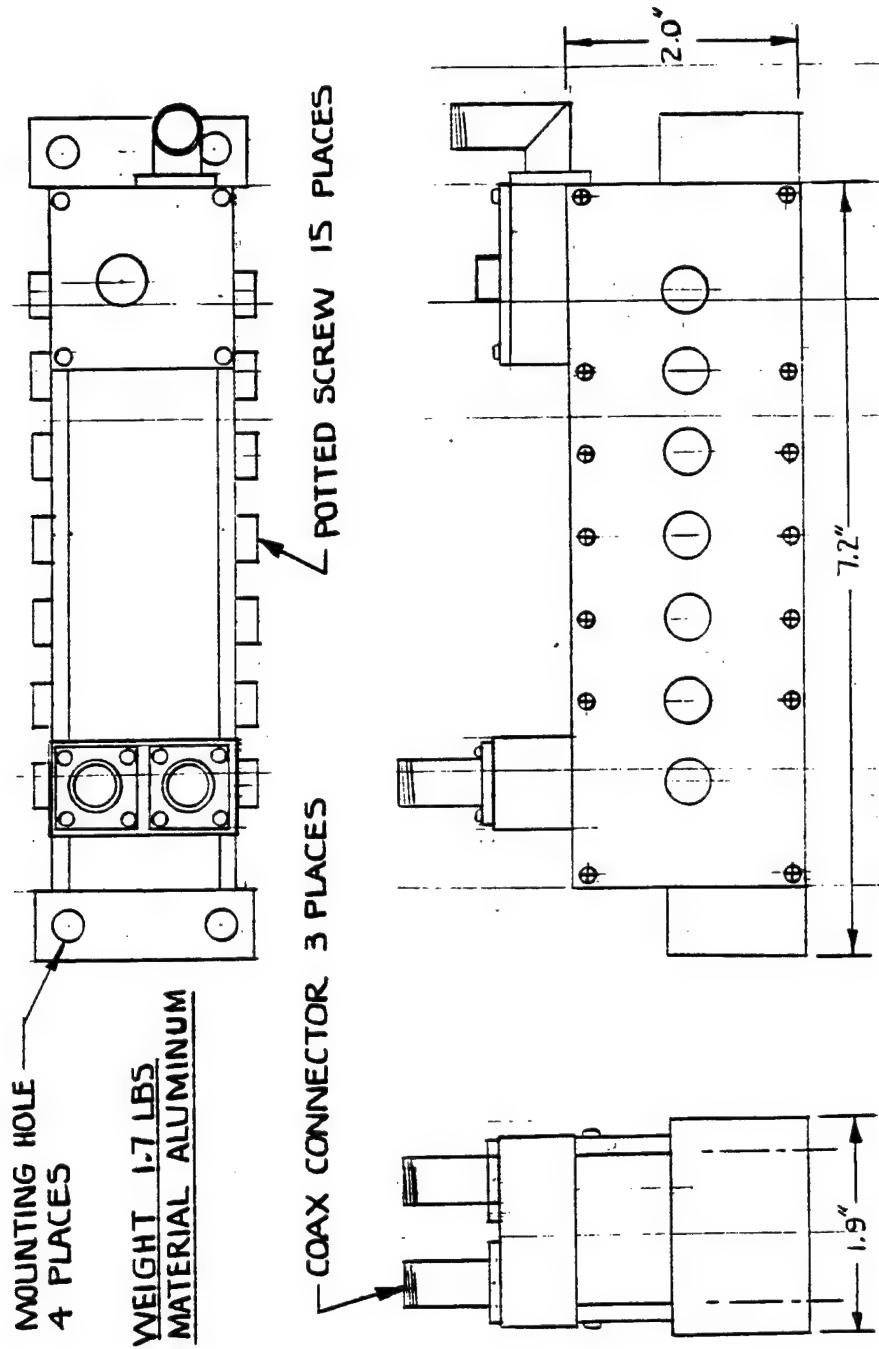
FIGURE 5-21
DIPLEXER CONSTRUCTION

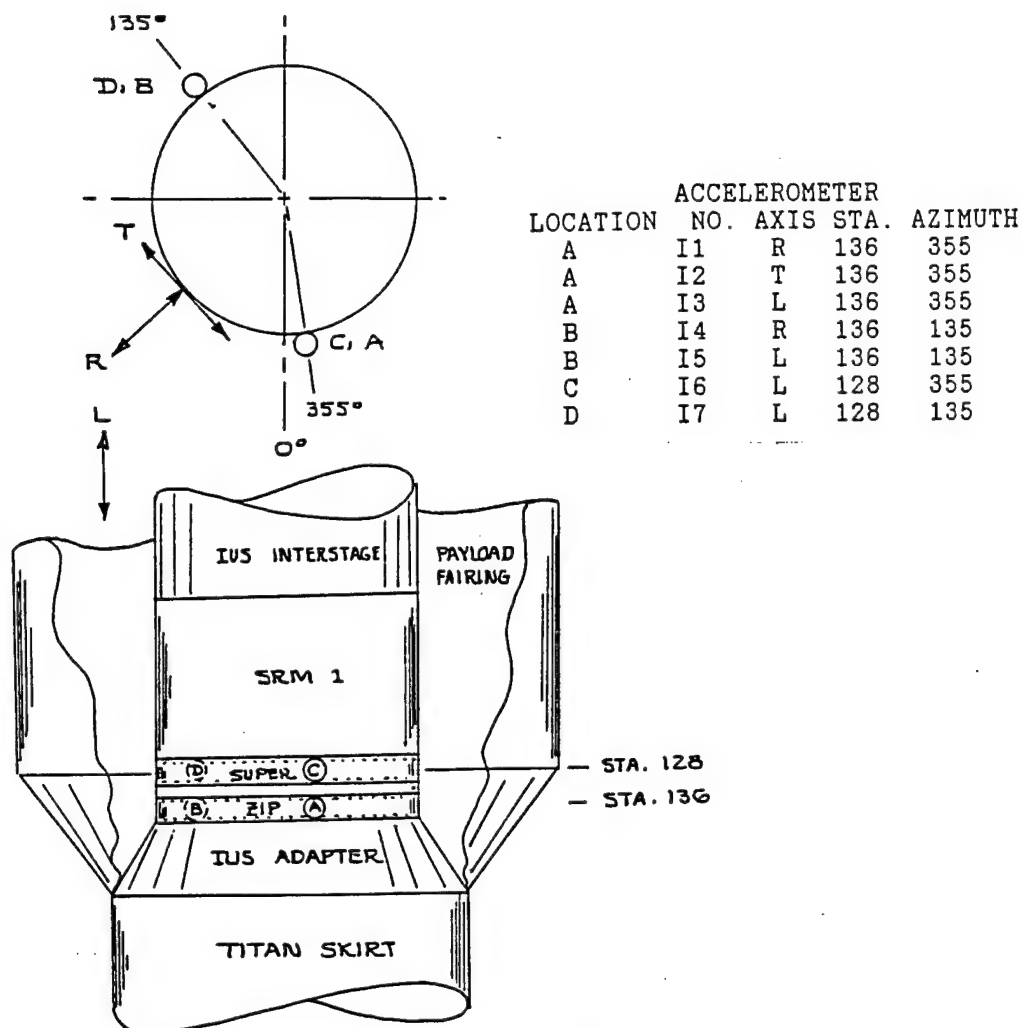
FIGURE 1
IUS ACCELEROMETER LOCATIONS
TITAN 4 PAYLOAD FAIRING SEPARATION TEST
JANUARY 1988

The shock spectra from all accelerometers were enveloped for each shock event (total of 4 events). The envelopes are shown in figure 2 and are compared to the interface maximum shock envelope from ICD-TIV/IUS-10102. The highest levels were recorded on accelerometers I1R and I4R. The shock spectrum from accelerometer I7L was not included in the data envelope for the force margin separation test. The shock spectrum was not considered valid because of a plus 20g bias noted in the acceleration time history.

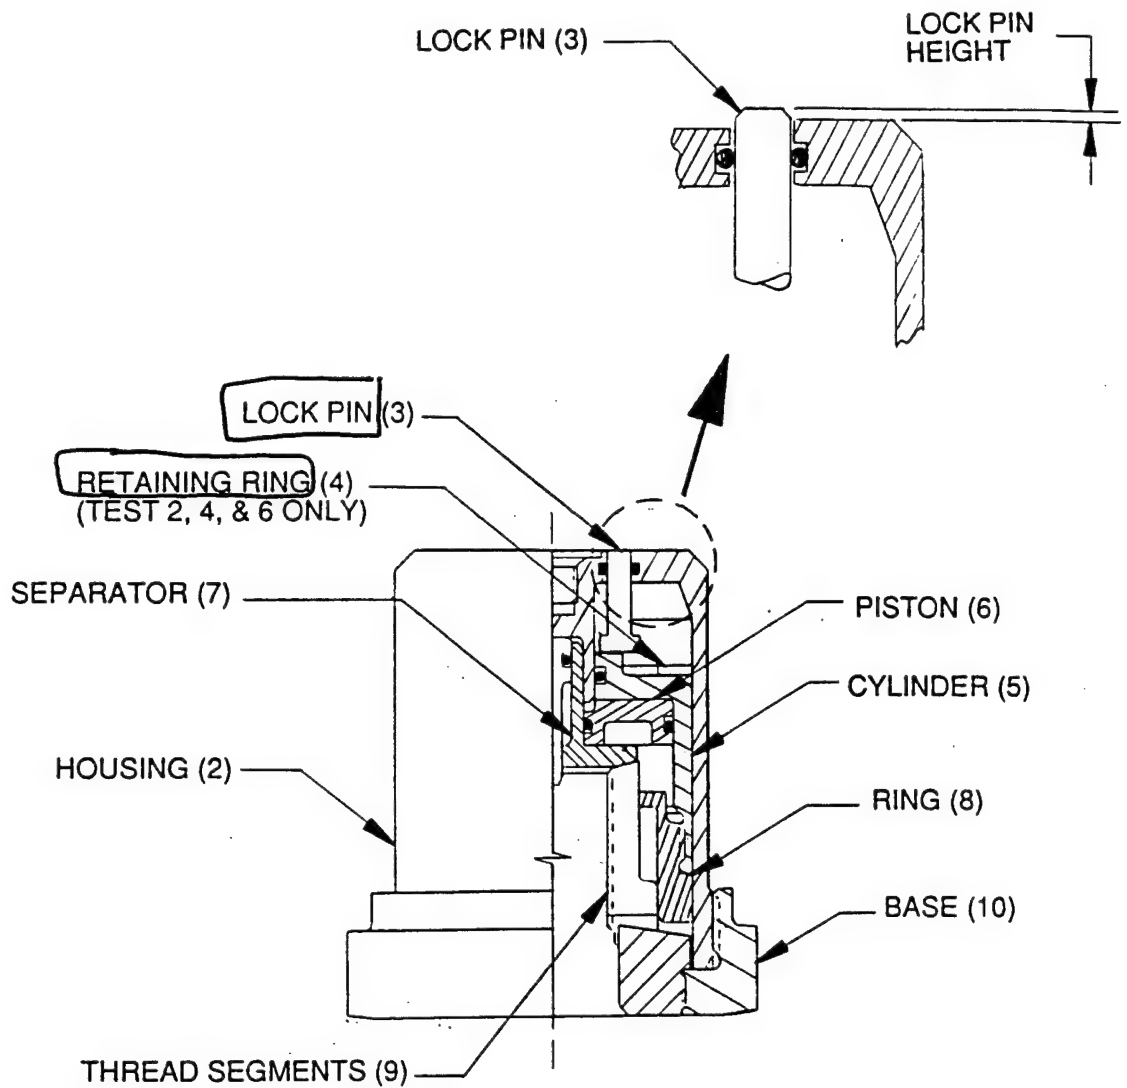
FIGURE 5
ASSEMBLED SEPARATION DEVICE
